Passenger door trim & lock mechanism removal on 02 BMW 3 Series Compact.

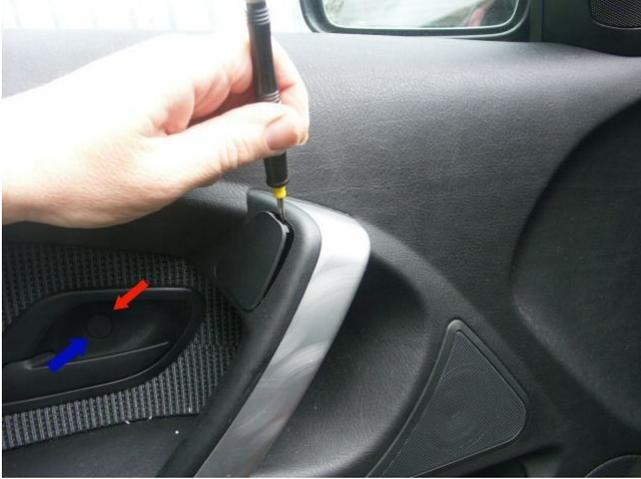
Picture 1. The small panel in the interior handle levers out quite easily with a small bladed screwdriver.

Note: taking this panel out *is not* required to remove the interior trim. I show it as if you're doing the drivers door you will probably need to pull it clear to remove the door mirror adjustment wiring.

To remove the two circular screw covers (the other is towards the lower rear area of the door above the storage compartment) press down firmly on the cover by the blue arrow and lever out with a thin bladed screwdriver by the red arrow.

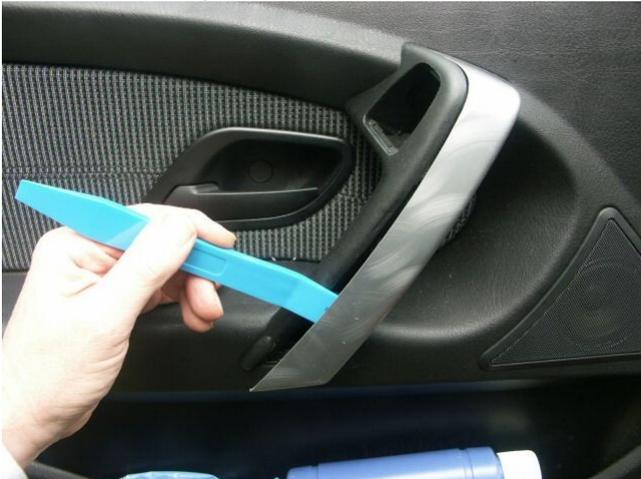
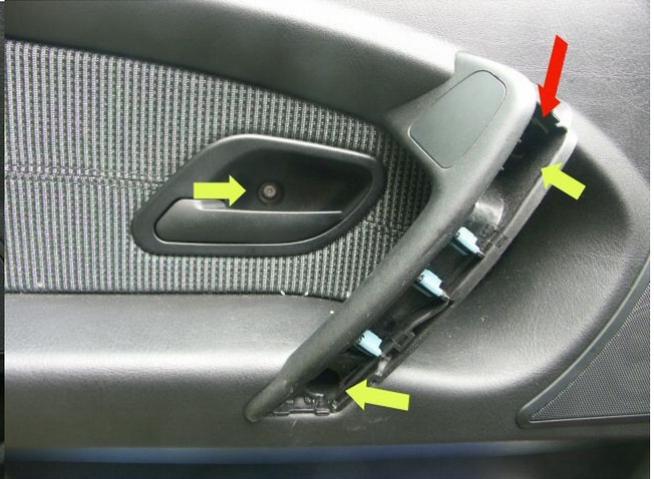
Pictures 2 & 3. Start removal of the silver trim from beneath using a screwdriver, then move upwards slowly working carefully on one side then the other. At the top the trim needs to be pulled up and forwards at the same time. The second picture shows the positions of the four mounting clips. In my case the top clip, position shown by the red arrow, remained inside the trim.

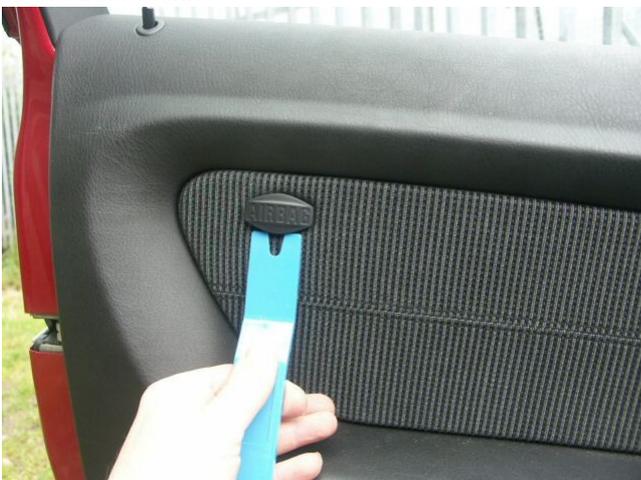
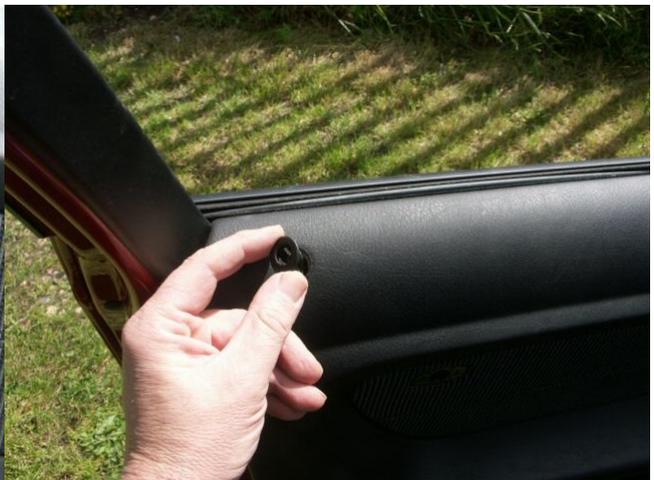
Pictures 4 & 5. There's a screw under the air bag logo which is easily removed. Lift out the plastic surround to the door lock.

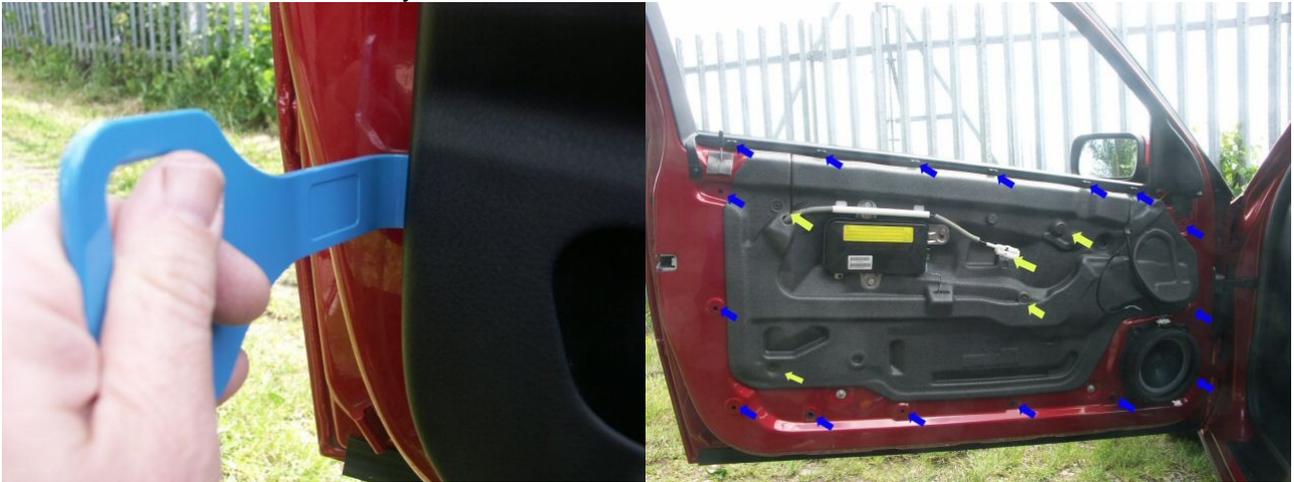
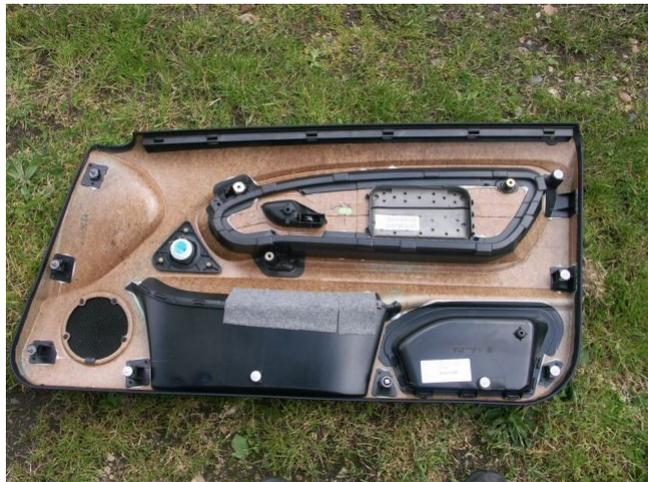
Picture 6 & 7. Remove five Torx 20 screws (yellow arrows show positions – see also picture 3) then work around the bottom of the trim, then the front and back, ideally using a purpose made trim tool. The blue arrows in picture 7 show the attachment points. Lastly go along the top carefully placing the tool between the trim and the windows seal. Once all the clips are released ease the trim forwards a few inches and disconnect the small speaker (if installed) then unclip the white nylon door release. Note the way it clips onto the door release handle for when you refit it.
